Varnish Removal at K-Electric, Bin Qasim Power Station-II (Issued by K-Electric BQPS-II)

Technology Release document - as lessons learnt

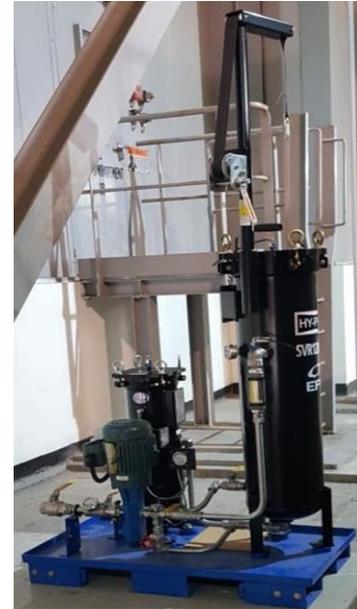
Hence after pre-requisites were arranged, Skid was delivered to site, Vendor mobilized his team from Oman and Successful Installation, commissioning & startup of Skid was carried out at GT-2 on July 14th, 2017, followed by product O&M training session to team.

Filters set was replaced after a month duration and on Aug 28th, 2017 the MPC levels dropped from 38 to 11. Results were verified through SGS Australia and comparable results were found. Confirming the success story.

Afterwards, the SVR skid was moved to GT-3 where again the varnish levels were dropped and then moved to Steam Turbine unit where it is currently performing its purpose.

Moving ahead, the decision has been taken to install dedicated HYPRO SVR skids during 2018, on each of the GTs 1,2,3 as a permanent mount to enhance the reliability of Gas Turbines.
